Stream Enhancement Evaluation

Queen Creek through the Town of Superior, Arizona Resolution Copper

June 2020

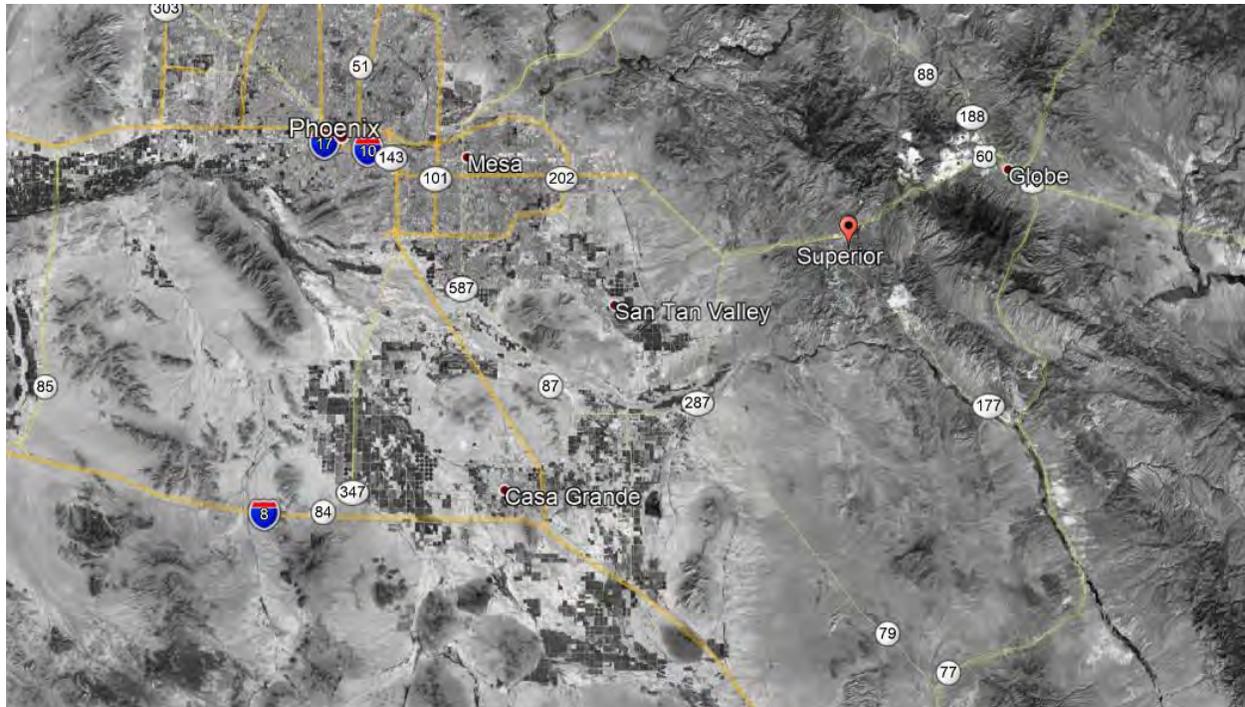
Figure 1. Project Location

The Town of Superior is located east of Phoenix, AZ at the base of the Apache Leap escarpment. Queen Creek headwaters are to the east of Superior and flow generally westward through the town towards San Tan Valley and are captured in Whitlow Ranch Reservoir.

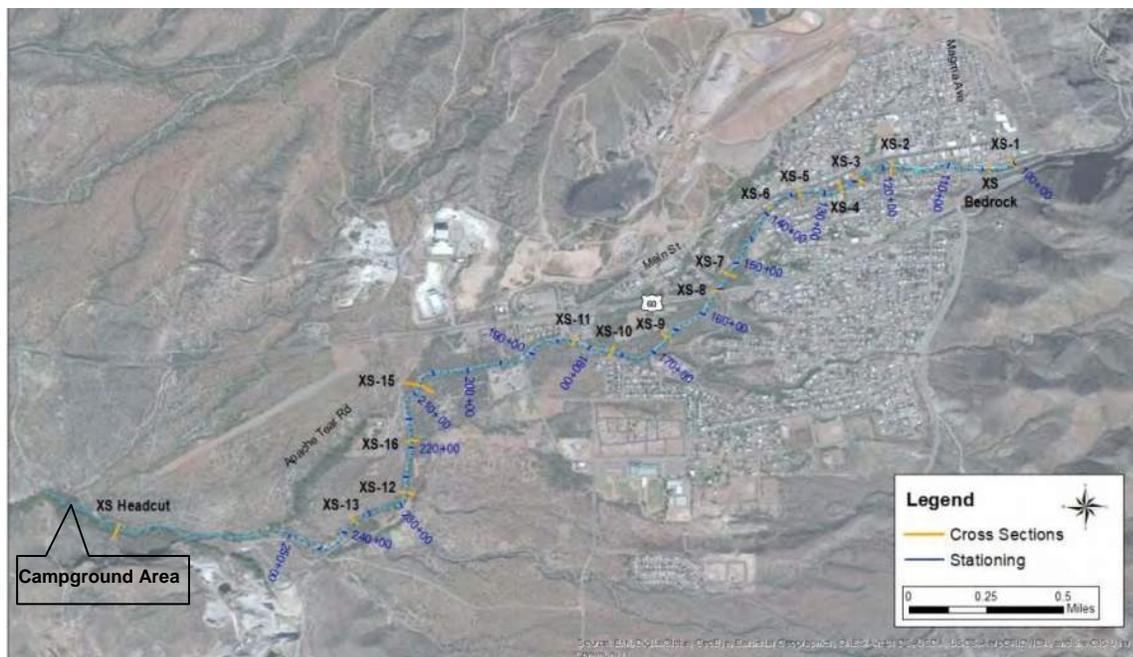
Figure 2. Location of geomorphic cross sections

Eighteen channel cross sections were surveyed throughout the project area to determine bankfull dimensions within the reach and compare with regional data and reference data. The locations of cross sections are provided in Figure 2. Dimensions for each cross section are provided in Table 1.

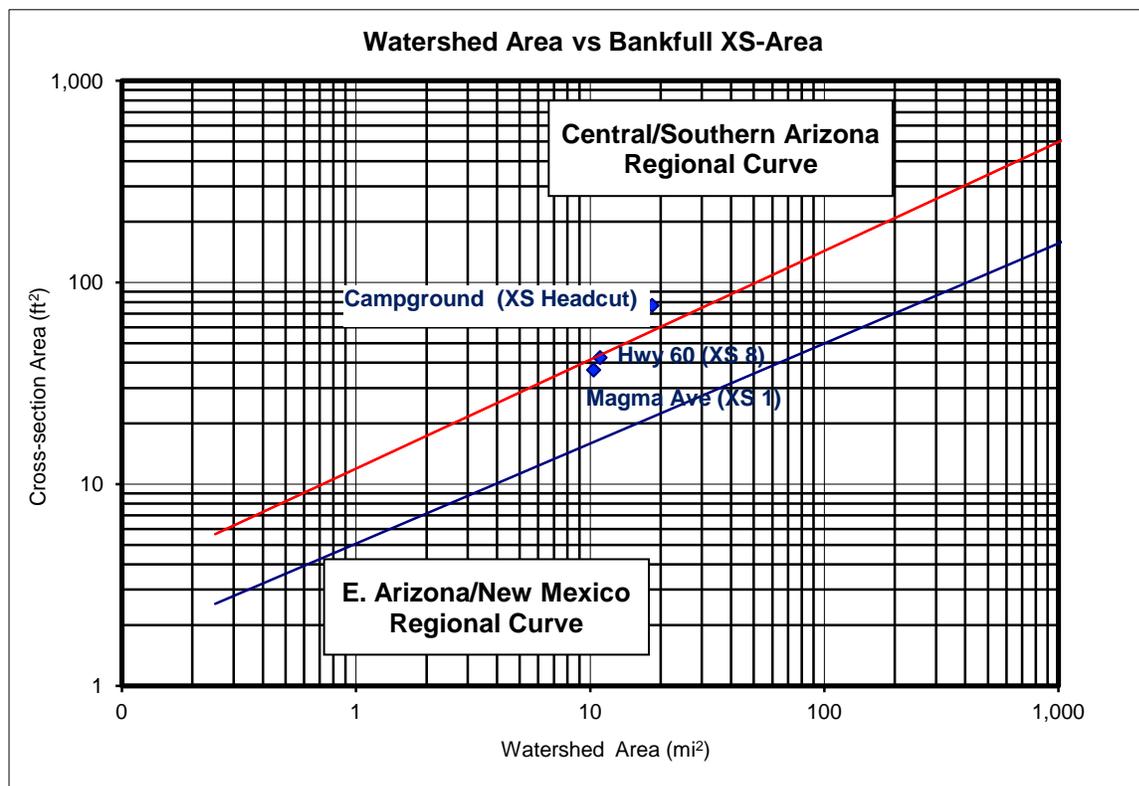
Figure 3. Regional curve for project area.

Cross sectional area and other related dimensions are typical for the watershed size and geomorphic setting of Queen Creek. Figure 3 shows how three cross sections fit on the regional curve for the central/southern Arizona region which shows the correlation of bankfull cross-sectional area as a function of watershed area (Moody, et, al 2003). There were no abnormalities or large-scale stream instabilities indicated from the cross section or longitudinal profile data. Longitudinal profile data indicate that channel slopes are relatively constant at approximately 2% with minor anomalies associated with low water road crossings and minor headcuts. See Appendix A for full geomorphic data. These data suggest that the geomorphology of the stream is not a general limiting factor for support of riparian habitat and good stream function.

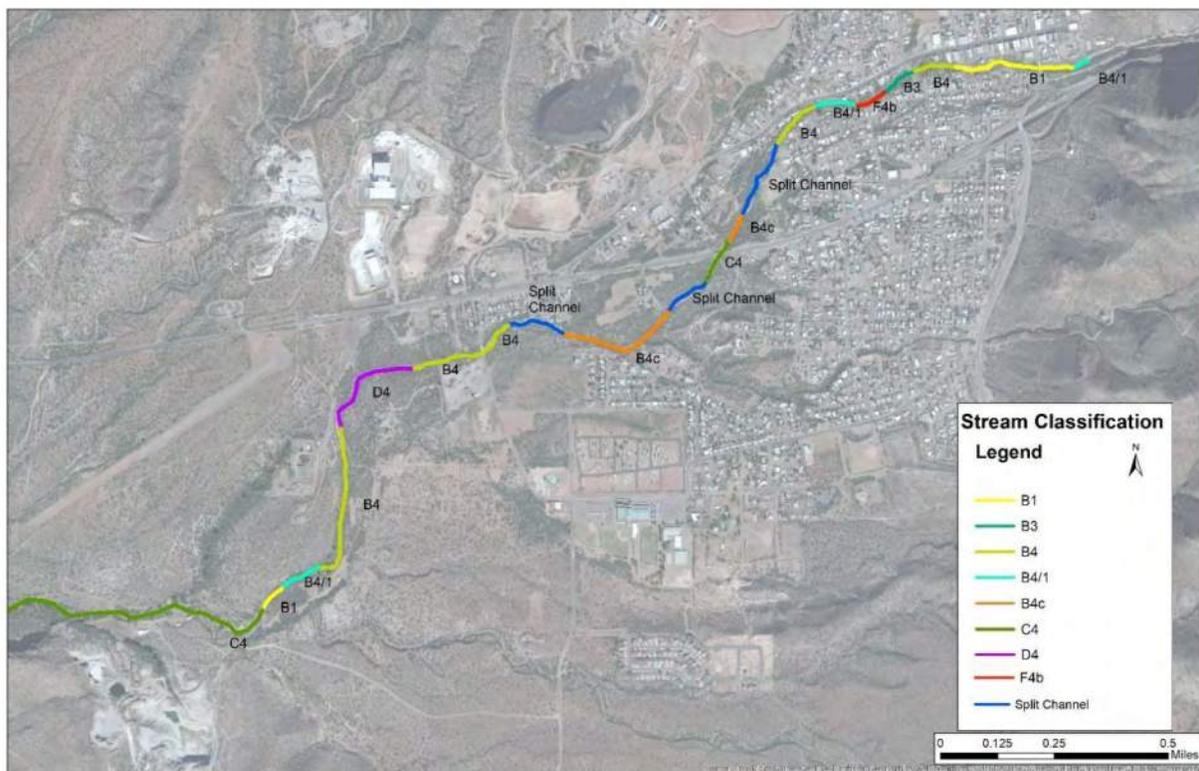
Figure 4. Stream types in Queen Creek.

B and C stream types are the expected, stable channel forms for the project reach based on channel slope. F, D and split channels are less stable areas with increased lateral instability and bank erosion. Queen Creek in Superior is predominately a stable B channel changing to a C channel where the slope flattens out. There is a brief section of an F stream type where the channel has a very low slope and a wide, flat bed. There is one section of a braided D channel and three sections of split channels.

The number following the stream type classification indicates the bed material of the active or bankfull channel: 1 for bedrock, 2 for boulders, 3 for cobble, and 4 for gravel.

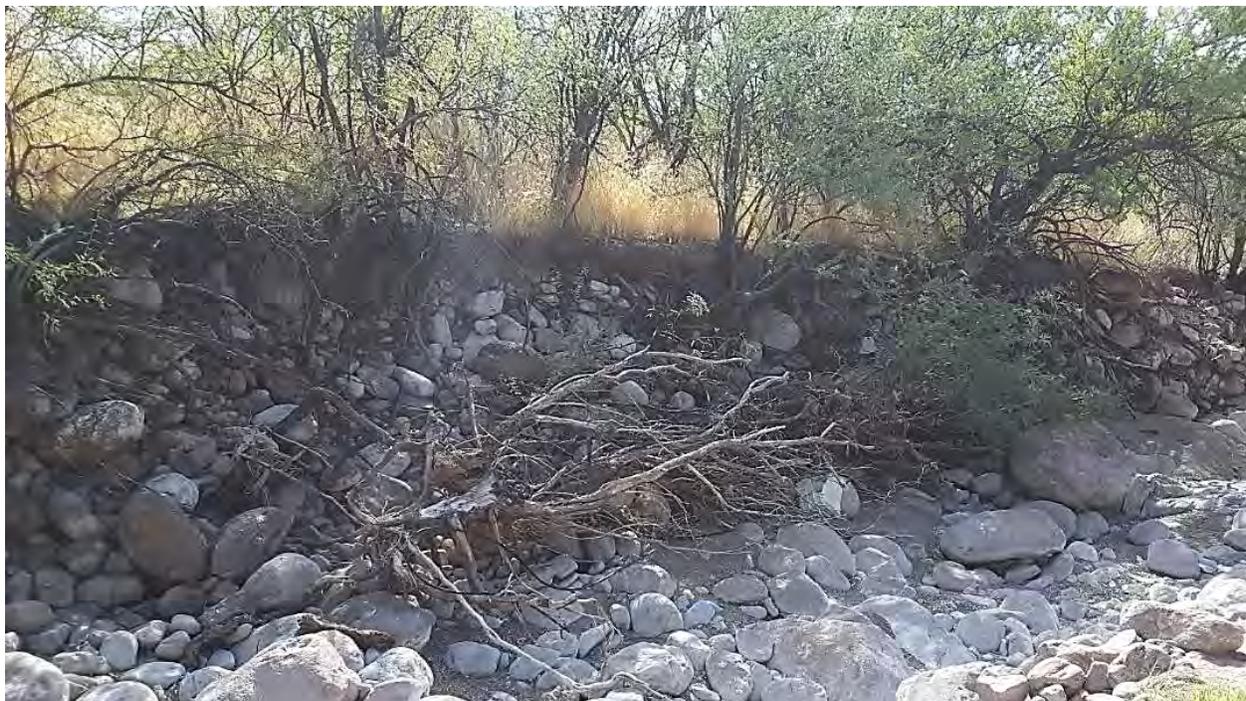
Figure 5. Actively eroding bank.

Bank erosion is not generally a concern in the Queen Creek project area. During the geomorphic survey, one actively eroding bank was documented upstream of Mary Dr (Figure 5). Several tall, vertical banks were also noted, however, these are not causing impairment or providing excess sediment (Figure 6). The active channel has pulled away from the bank due to the building of a bench or fallen debris. Bank erosion is not prevalent enough to create sediment supply issues for the stream. However, few localized bank erosion sites may warrant attention to prevent degradation of habitat or loss of private property.

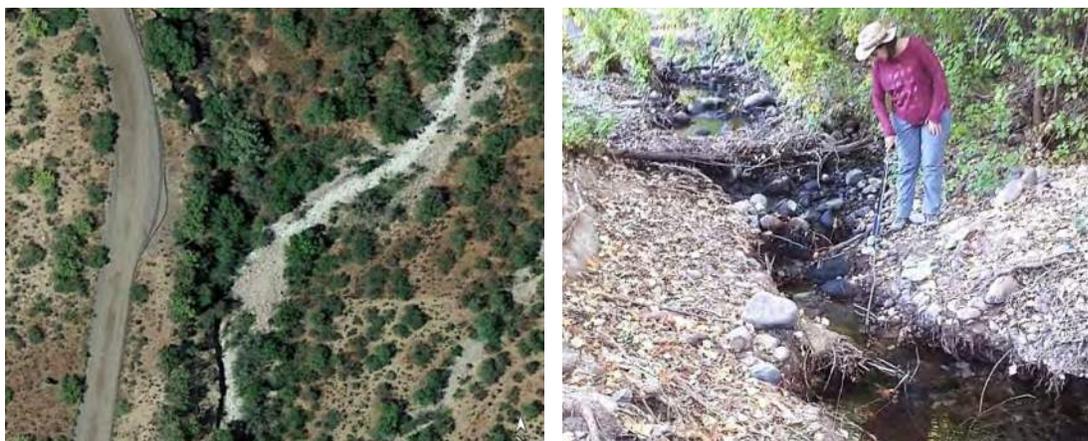
Figure 7. Two headcuts: near treatment plant (left) and upstream of campground (right).

Headcutting is a minor problem in Queen Creek. Two headcuts were documented in the project area: one near the road to the wastewater treatment plant gate and the other upstream of the campground (Figure 7 & Figure 8). Because headcuts can move rapidly during a single run-off event with devastating effects on stream stability and habitat, repair of headcut areas should be a paramount priority for management action.

The Google Earth image on the left shows that as the channel goes around the corner (stream flows toward bottom of image), it suddenly becomes incised and develops a vertical bank (shadow on left bank).

The suggested treatment for these areas is a cross vane weir such as the one shown below in Figure 15. These structures are constructed from large native rock placed in a chevron formation in the stream. The 'V' is on the upstream side placed at the grade of the stream. The 'arms' reach downstream at a slight angle upwards to the floodplain elevation. The structure forms protection against headward erosion while maintaining channel dimensions and sediment transport capability. Installation requires some design work to determine rock size, and weir dimensions. Installation requires an excavator with the ability to lift the proper sized rock. Weir construction is within the jurisdictional waters protected by the federal Clean Water Act and will require an appropriate permit from the Army Corps of Engineers.

Both headcuts (near the treatment plant and above the campground) will likely require a two-step cross vane weir which NCD estimates will cost \$15,000 for each weir (or \$30,000 total).

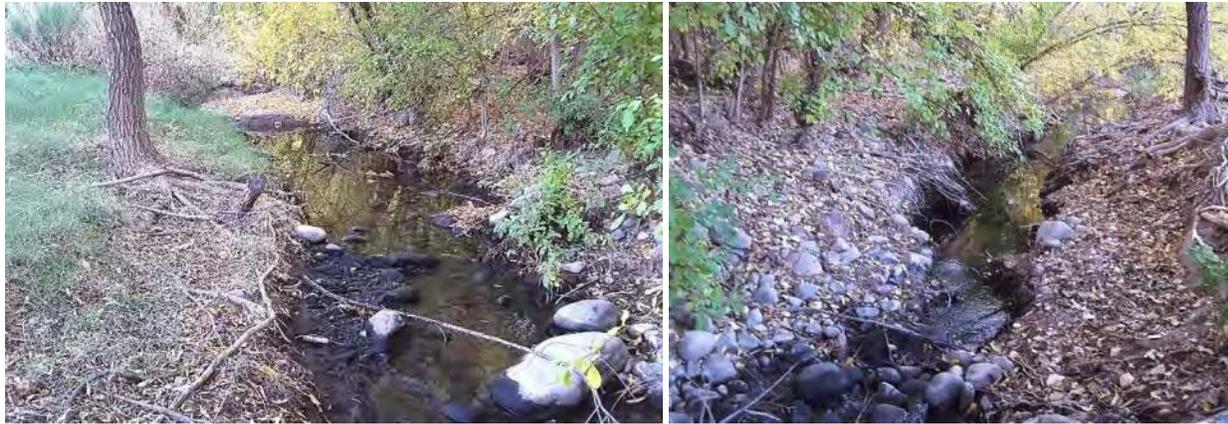
Figure 8. Above and below campground headcut.

The channel immediately upstream of the campground headcut (left) can easily access its floodplain, while the channel immediately downstream (right) is incised and cut off from its floodplain.

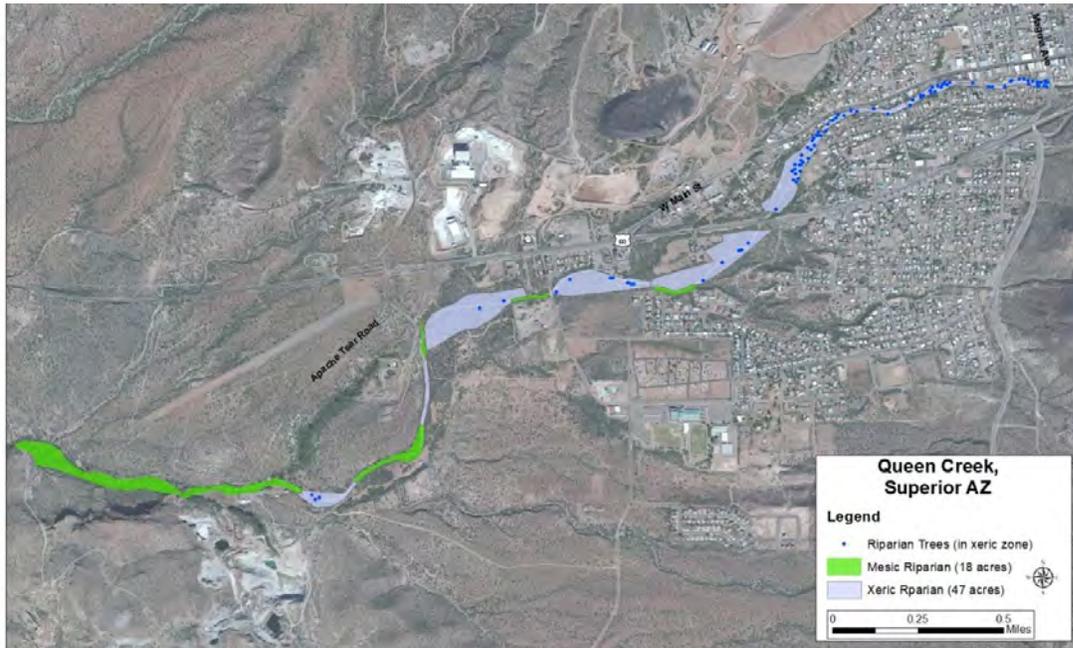
Figure 9. Location of mesic riparian trees.

The riparian vegetation along Queen Creek is diverse and relatively healthy xeric riparian community. Xeric implies that most of the species don't require permanent water and can live with intermittent wetting from flooding. This community may consist of the same species found on higher ground but have forms that are more robust and communities that are denser than those found on adjoining hill slopes. This is a common condition throughout the arid southwest and provides high quality habitat. While the xeric community of mesquite and associated plants is widespread through the corridor, there are pockets of more water loving riparian plants not associated with the hill slopes. These pockets consist of riparian trees including cottonwood, Goodding's willow, Arizona sycamore, Arizona walnut, velvet ash, netleaf hackberry and yellow and blue palo verde. The locations of these patches of more water-loving trees may indicate that shallow groundwater is available to the roots during most, if not all, of the growing season. These areas of mesic vegetation are more widely dispersed in the lower portion of the project area as flows from the wastewater treatment plant and a local perlite mining operation increase the length of time base flows exist in this reach. Older cottonwoods in the lower reaches exhibit dead tops, indicating that they may have been stressed for water at some point. It is suspected, but not confirmed, that the die off in the tops of these trees may have been associated with lack of flow from the Perlite mine during extended mine shutdowns, since the discharge is reliant on pumping from the mine. Monitoring wells in this area

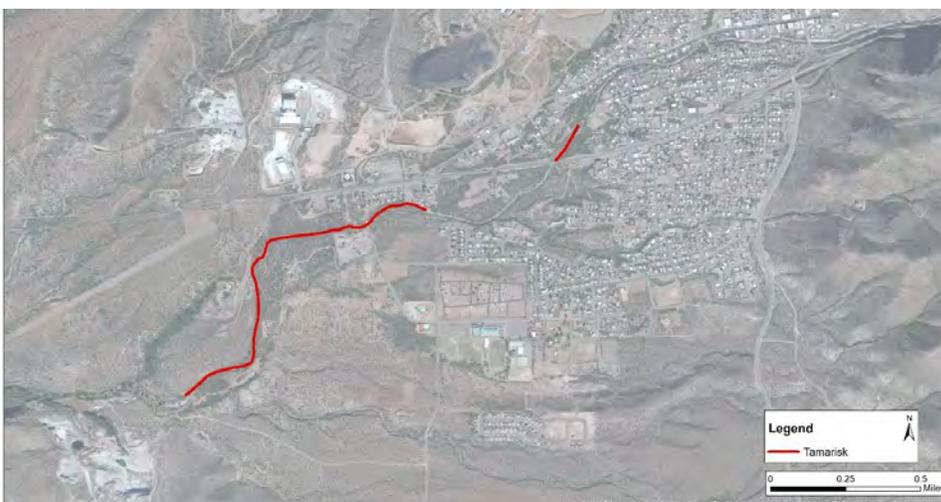
Figure 10. Tamarisk distribution in Queen Creek.

While the riparian community is generally in good condition, there are some nonnative species of concern. Two of the most problematic are tamarisk (*Tamarix ramosissima*) and fountaingrass (*Pennisetum setaceum*) (see Figure 10). Both species are aggressively invasive and have the potential to greatly diminish the quality of the riparian habitat if allowed to disperse further. There are other nonnative species that are found within the corridor. However, these two species currently are the most widely dispersed and are recognized as the most aggressive invaders. NCD has written an invasive plant management plan that provides detailed information on managing all the existing invasive plant species. See Appendix B.

- Tamarisk should be chemically treated using a cut stump method in summer or fall when the plant is growing and not water stressed. A single treatment should significantly reduce the existing population. However, tamarisk can resprout and a follow up treatment the next year is recommended.

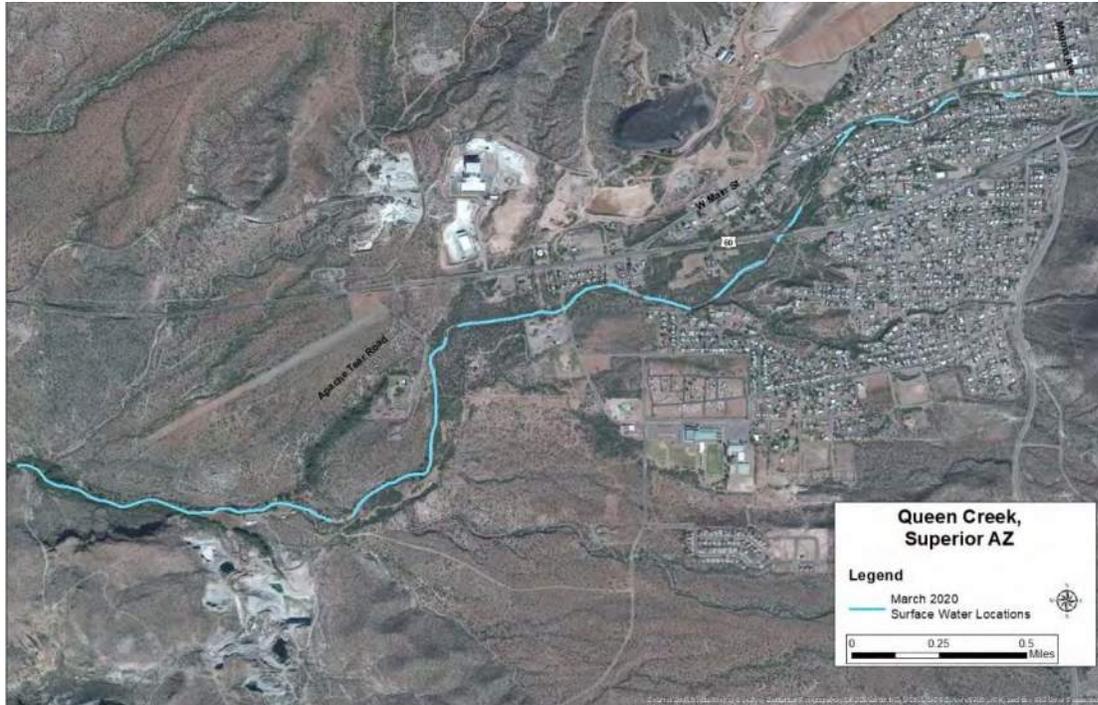
Figure 11. Surface water locations during a March 9, 2020 survey.

Flows in Queen Creek are intermittent throughout the reach. Losses of surface flows appear to be tied to two different causes which have different implications for stream and riparian function.

Intermittent flows throughout the remainder of the reach appear to be driven by depth of alluvium. When alluvium is deep flows tend to be lost to the deeper soils. When bedrock is near the surface, underground flows are forced to the surface. NCD conducted a survey in March 2020 to map surface water locations during an intermittent flow period from Magma Avenue downstream. Runoff was very low with discharge through some sections and no surface water at all in others (Figure 11). The surface flows match up well with the exposed bedrock locations mapped during previous surveys (Figure 12). These locations are also aligned with higher incidence of more mesic vegetation noted in the vegetation survey (Figure 9).

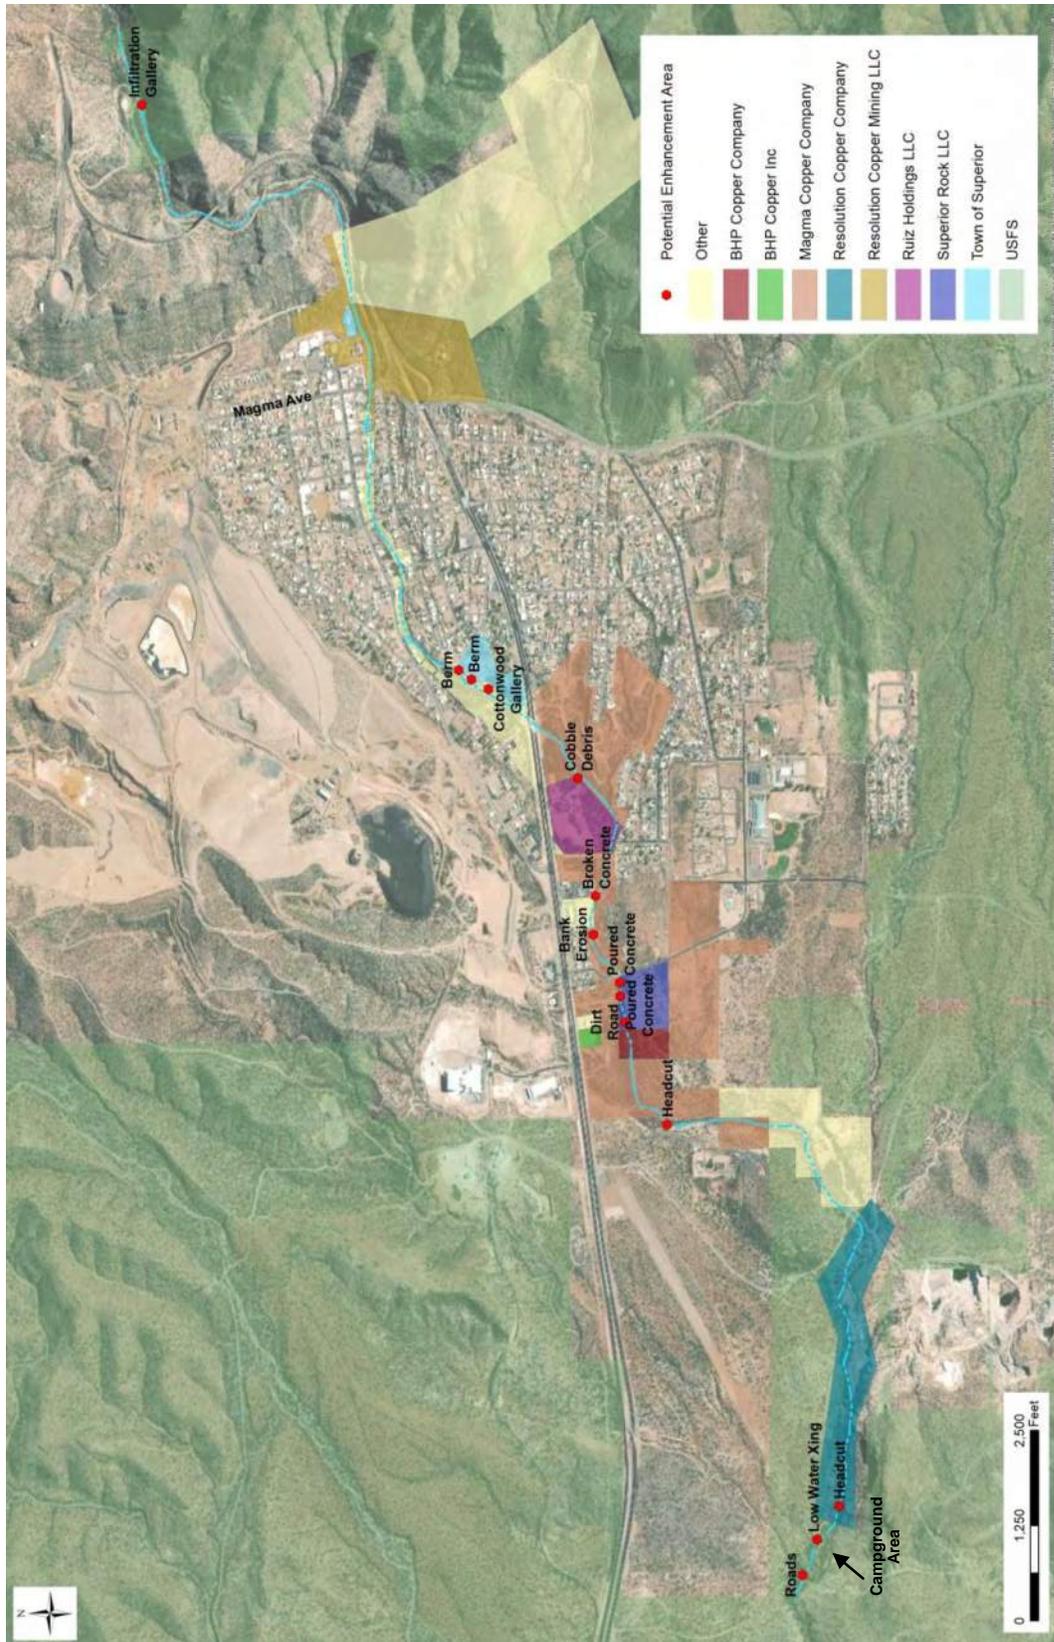
Figure 13. Locations of various problem areas in Queen Creek.

There are several potential enhancement alternatives that can be considered as stand-alone projects or in combination with other alternatives (Figure 13). The alternatives can roughly be divided into two types, those that aim to rehabilitate, restore, preserve and conserve the current stream and riparian character and those that have the potential to alter the stream or portions of it into a more desirable state. It should be noted that the ‘rehabilitate, restore, preserve and conserve’ actions are generally more assured of positive results and sustainable. Alternatives that involve the ‘restructuring and changing of the stream’ to wetter and more vegetated state would require considerably more information to be collected before success can be assured, more water than the stream currently experiences, and are less sustainable. Alternatives are discussed in more detail below.

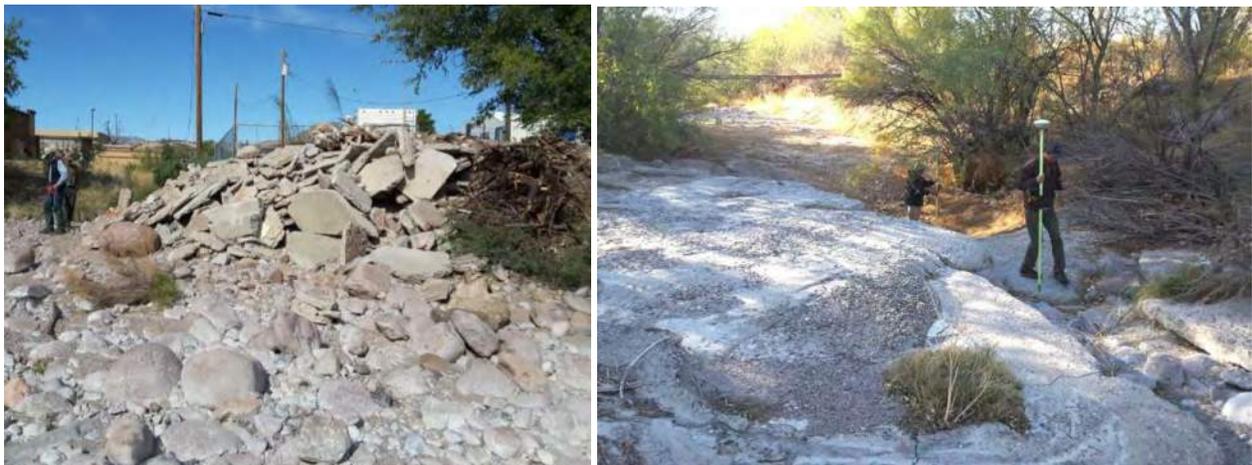
Figure 14. Typical non-native fill in the channel.

Several key locations of the channel and floodplain have been impacted by debris and fill (Figure 14). This material affects water quality, flows, floodplain function, and aesthetics. Removal will require heavy machinery, dump trucks for haul away and a secure dumping site. The largest area for removal is downstream of Mary Dr near the concrete yards. It is difficult to accurately measure the total amount of material but 50 to 100 cubic yards of material have been pushed over the bank into the channel and floodplain. The majority of this material is concrete either in broken slabs or as poured and solidified form. There is also some native fill that has been pushed into the channel as well. Material should be removed, exposing native soil. All disturbed areas should be planted with native grass and shrub seed. Other areas up and down the channel have collected trash and litter which can be cleaned out by volunteer or hand crews. Cleanup efforts should be announced and utilized as an outreach and education effort for the community.

Broken concrete upstream of Mary Dr (left photo) and poured concrete in channel below Mary Dr (right photo).

Cost estimates to clean up these debris areas are \$950 for the cobble pile, \$1,900 for the broken concrete pile, \$18,000 for the poured concrete, and \$600 for the dirt road crossing.

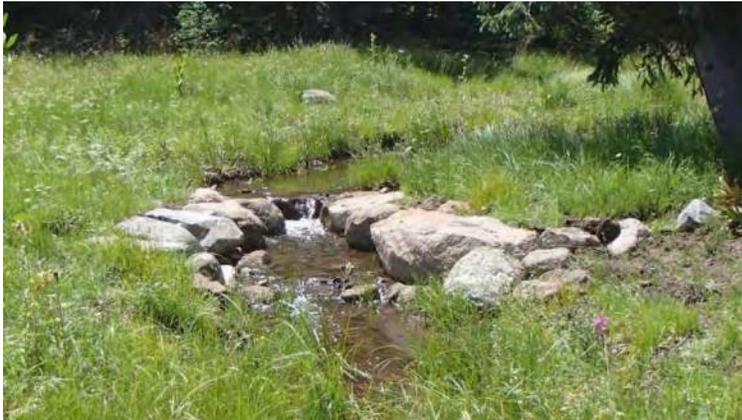
Figure 15. Cross Vane Weir example.

This cross vane weir protects the stream gradient and defines the active channel dimensions.

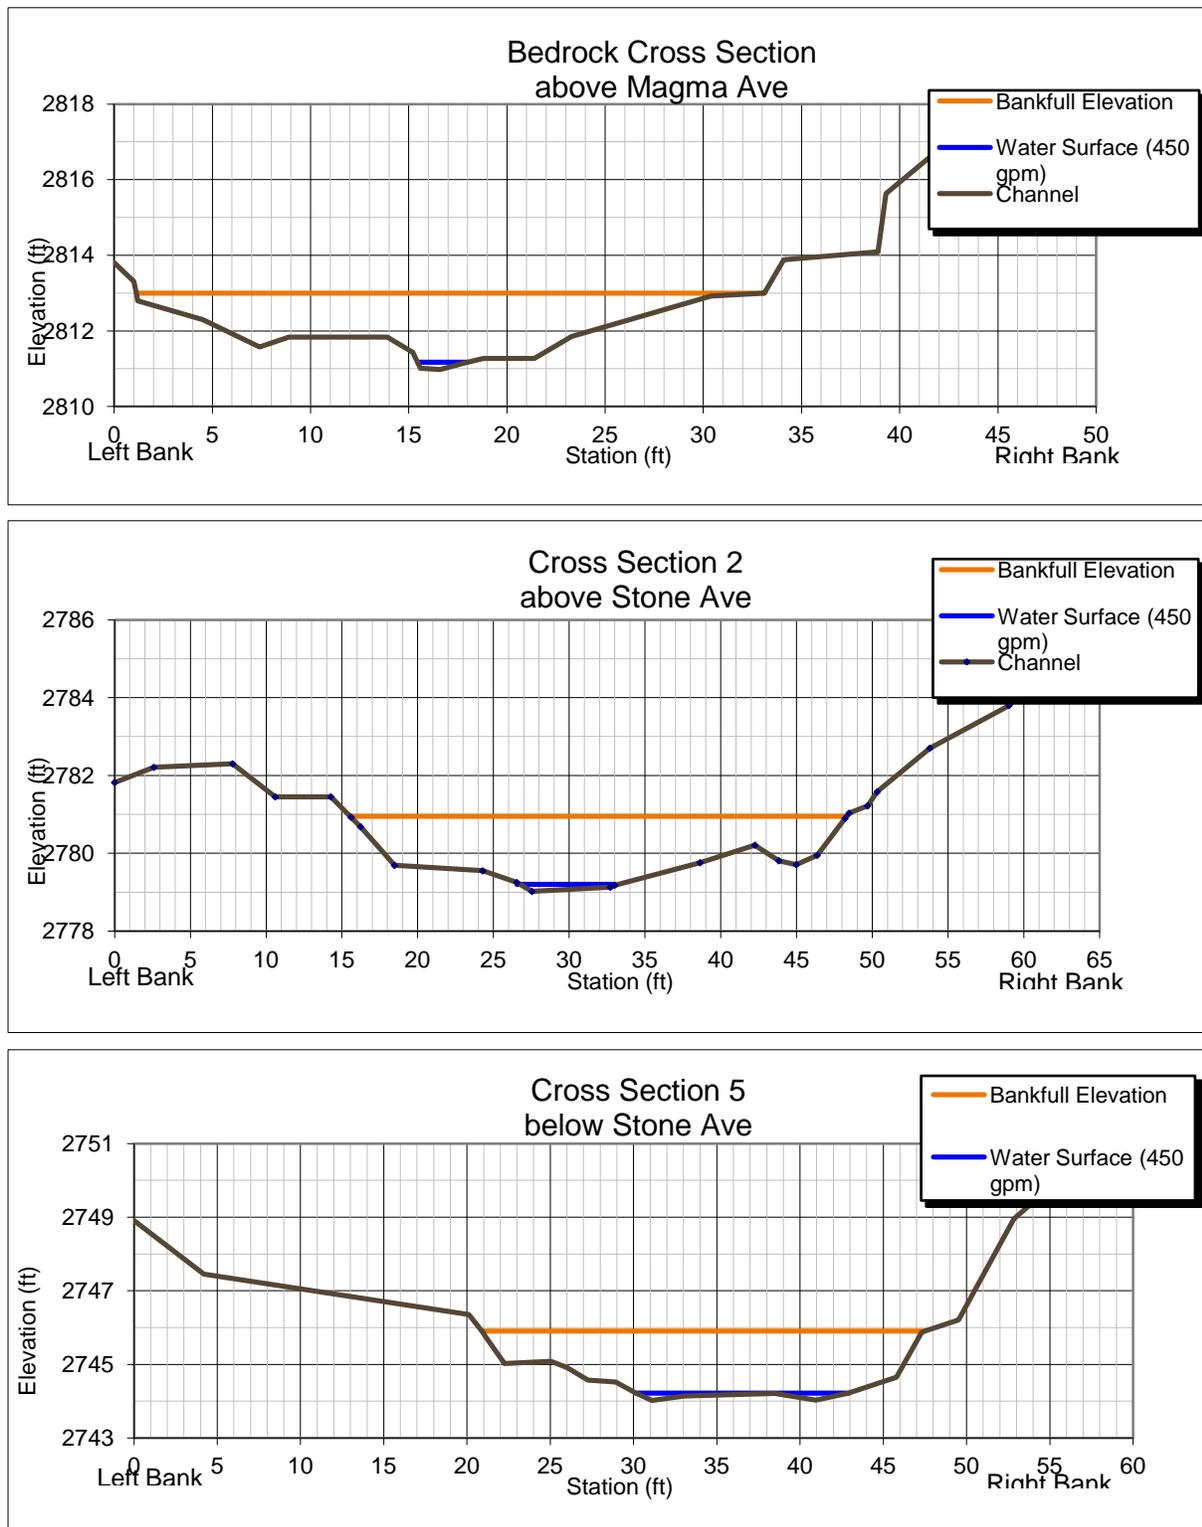
Figure 16. Hydraulic analysis of 450 gpm in typical stream cross sections.

Cross sections from the geomorphic study were also used in preliminary hydraulic modeling to show potential visual effect of increased water in the channel at various locations. Figure 16 shows the water level for 1 cfs (450 gpm) at three different cross sections which results in a water level that is about 0.2

450 gpm is 18 times the available additional flow but is smallest flow that could be modeled with this method.

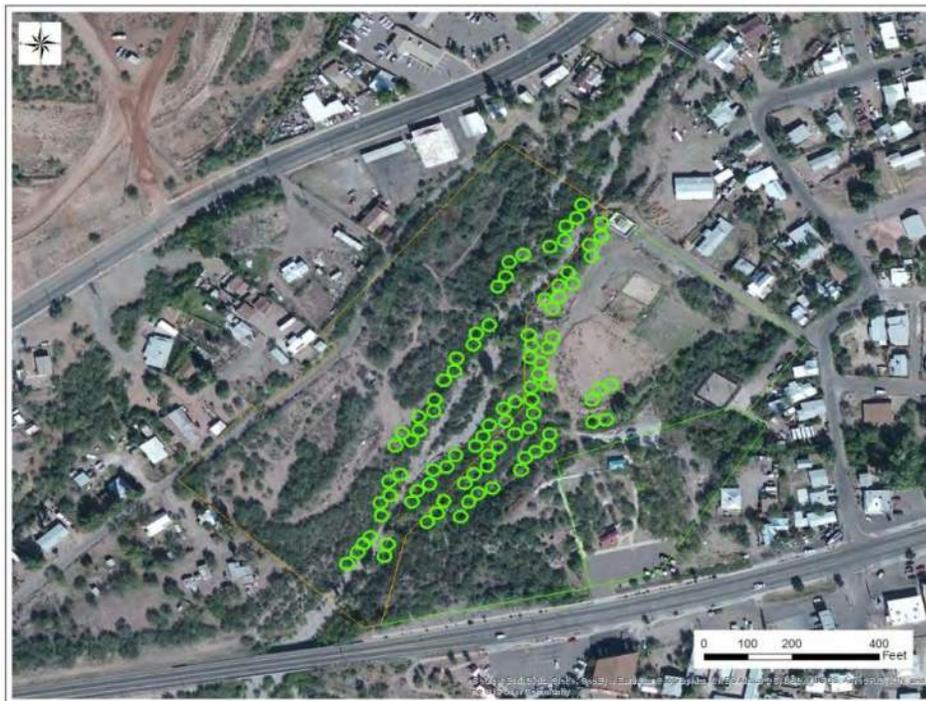
Figure 17. Potential cottonwood planting area at Town of Superior Park.

Additional vacant private land on west side of channel is high elevation but can provide some suitable planting space.

- Plant cottonwood poles or containerized stock. Suggest working with Northern Arizona University Cottonwood research group to select genotypes that are drought tolerant and adapted for likely climate conditions over the next 50 years. This research group can select stock and will use data collected from the site for scientific research on community genetics.

- Establish trees with irrigation for 3 to 5 years
- Once trees are established, the irrigation water can be turned into the stream channel at Magma Avenue. Flows will provide surface flow amenity and recharge the alluvium at the cottonwood restoration site (Figure 17) for long-term sustainability. Excess flows will continue past the bridge and recharge the deeper alluvium.

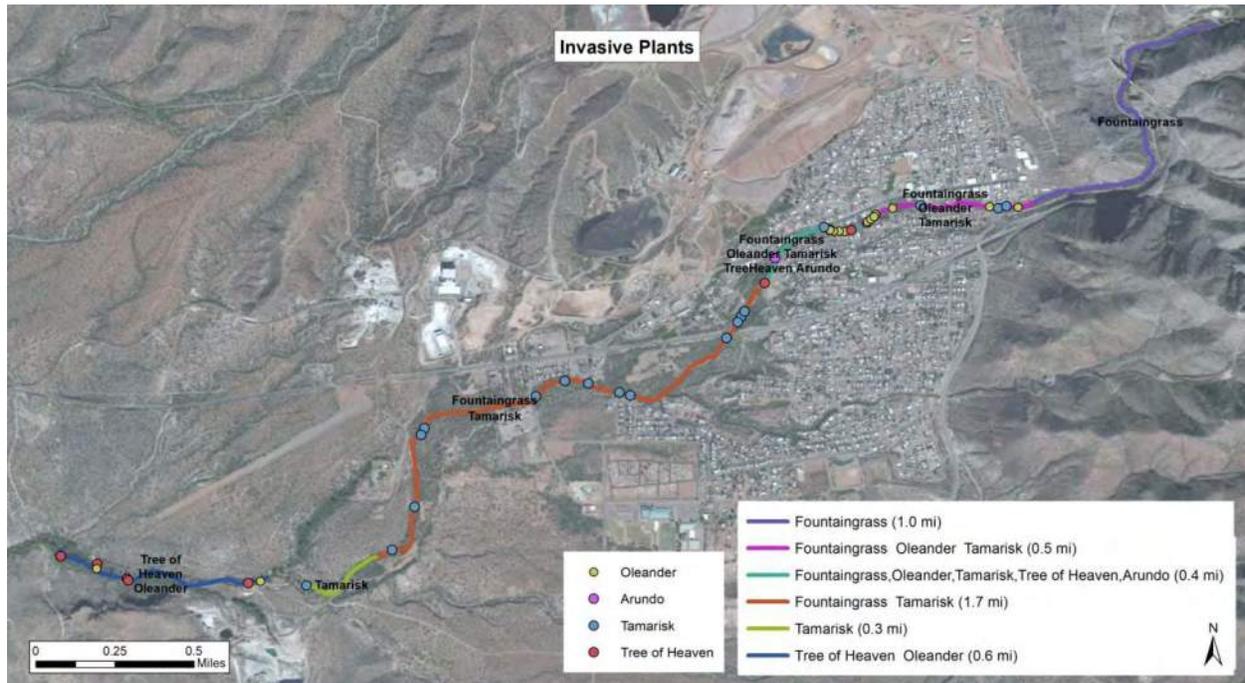
Figure 2. Invasive plant locations found during NCD surveys.

Below is list of invasive species found during NCD's stream surveys (Figure 2) as well as those mentioned in WestLand Resources, Inc. (WestLand) draft vegetation assessment and the Town of
