**GEOTECHNICAL EVALUATION
FIRE STATION
GOLF COURSE ROAD AND MARY DRIVE
SUPERIOR, ARIZONA**

March 10, 2004
Project No. 600777001

Subject: Geotechnical Evaluation
Fire Station
Golf Course Road and Mary Drive
Superior, Arizona

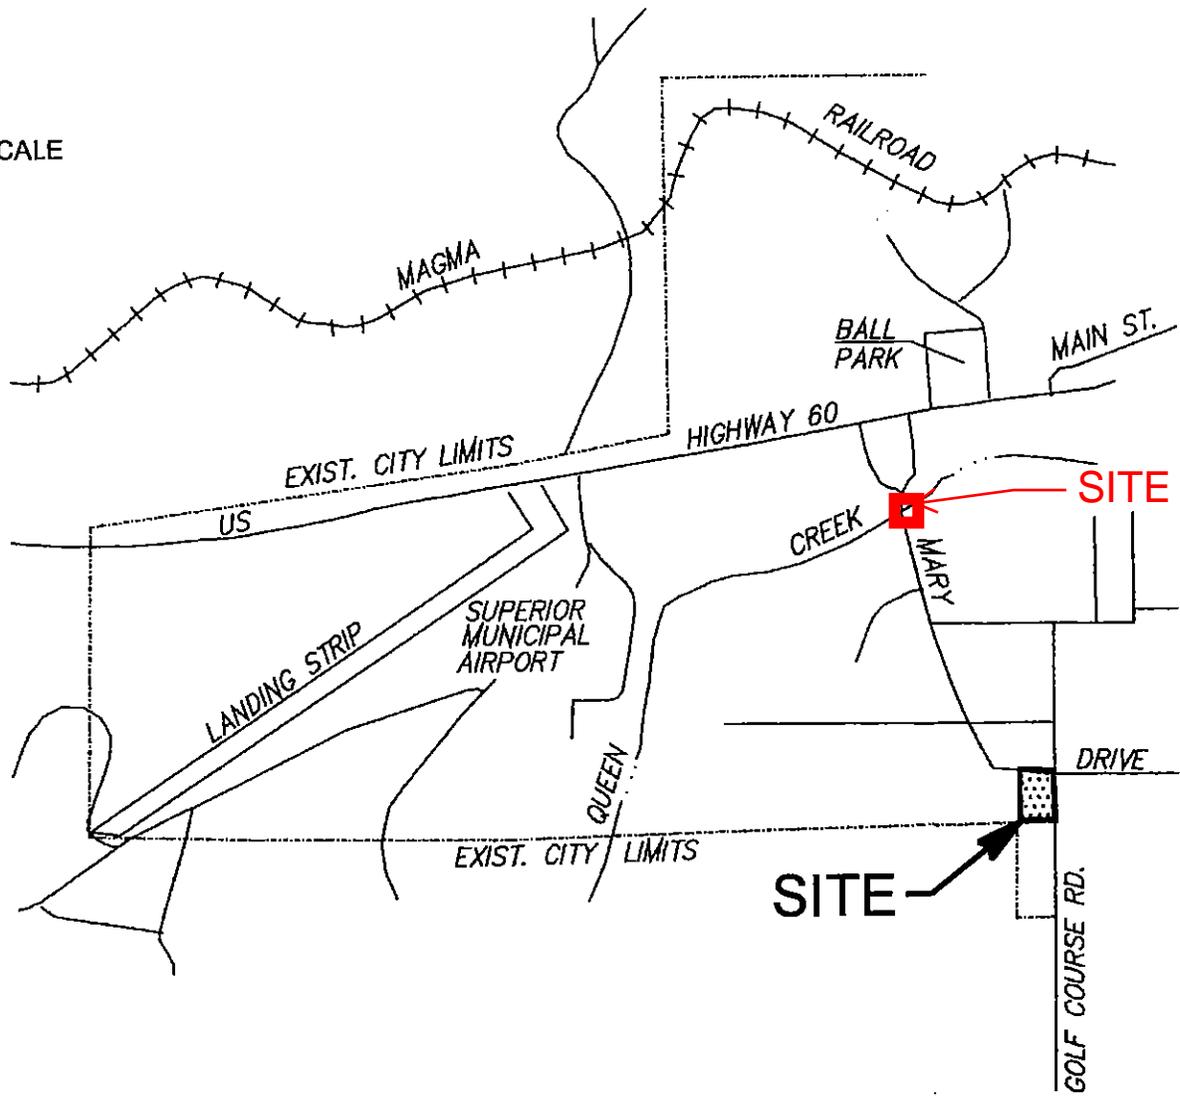
NOTE:
QUEEN CREEK IS ABOUT 0.36 MILES FROM THE STUDIED LOCATION

Figure 1 – Site Location Map

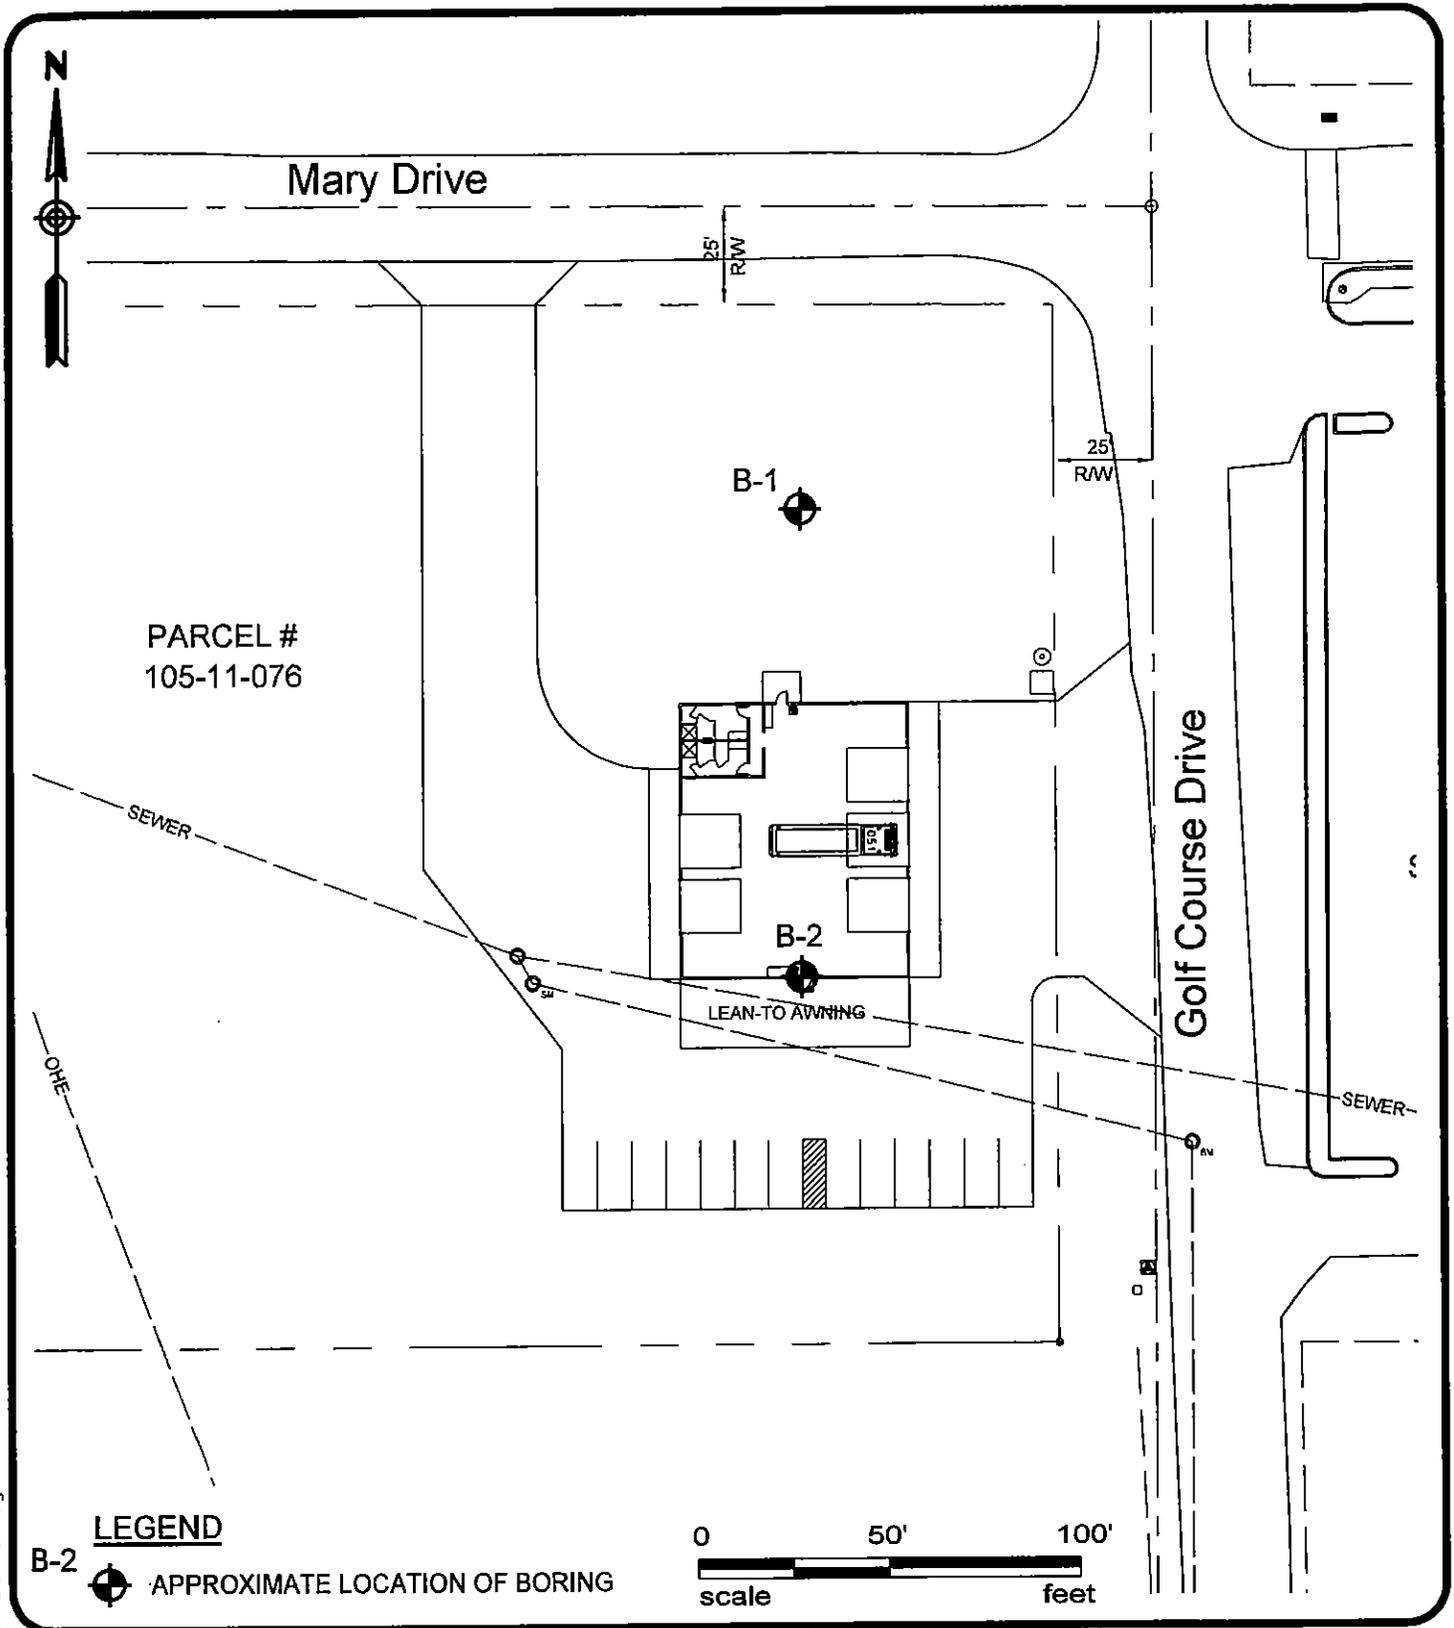
BORING LOCATION MAP

SUPERIOR FIRE STATION
GOLF COURSE & MARY DRIVE
SUPERIOR, ARIZONA

Figure 2 – Boring Location Map

On February 17, 2004, Ninyo & Moore conducted a subsurface evaluation at the site in order to evaluate the existing subsurface conditions and to collect soil samples for laboratory testing. Our evaluation consisted of the drilling, logging, and sampling of two small-diameter borings. The borings were advanced using a CME-75 truck-mounted drill rig. The borings were planned to be drilled to an approximate depth of 15 feet bgs. However, auger and sampler refusal was encountered at approximate depths of 7.5 feet in boring B-1, and 13.6 feet in boring B-2. Bulk and relatively undisturbed soil samples were collected at selected intervals. Detailed descriptions of the soils encountered are presented on the boring logs in Appendix A. The general locations of the borings are shown on the Boring Location Map (Figure 2).

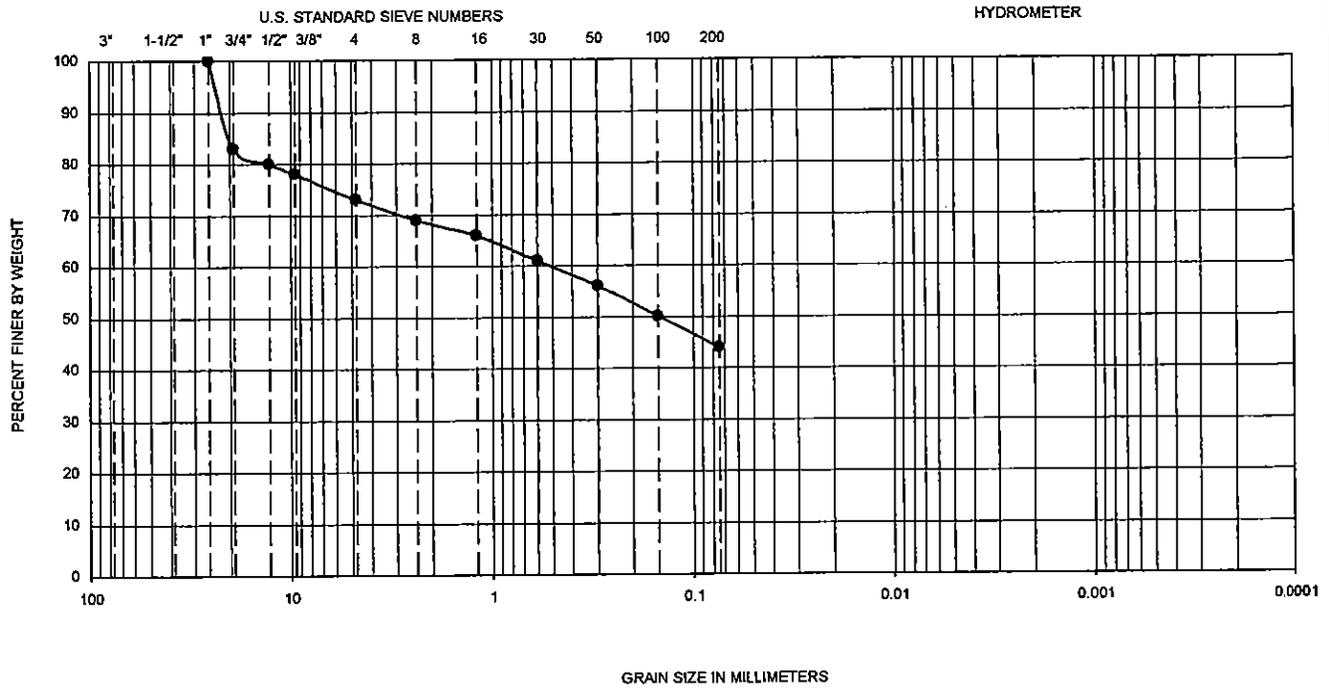
Symbol	Hole No.	Depth (ft)	Liquid Limit	Plastic Limit	Plasticity Index	D ₁₀	D ₃₀	D ₆₀	C _u	C _c	Passing No. 200 (%)	U.S.C.S
●	B-1	1.0-2.5	--	--	--	--	--	--	--	--	44	SC

PERFORMED IN GENERAL ACCORDANCE WITH ASTM D 422-63

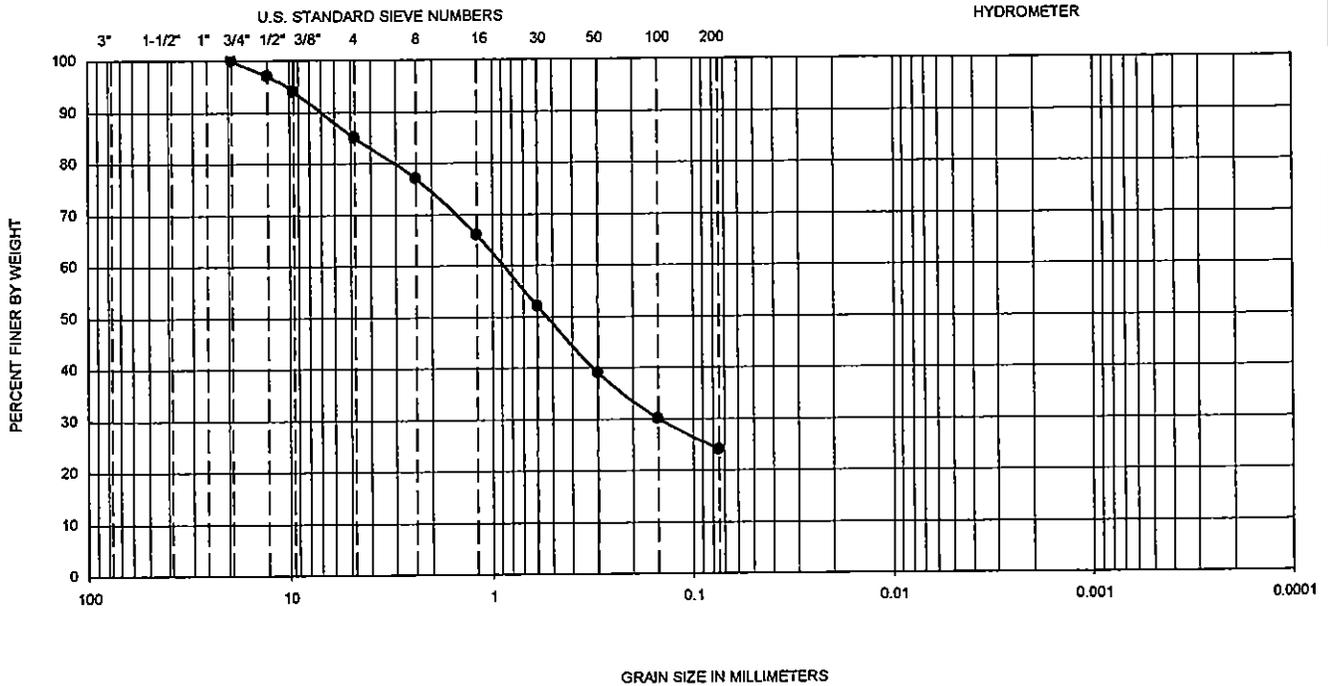
Symbol	Hole No.	Depth (ft)	Liquid Limit	Plastic Limit	Plasticity Index	D ₁₀	D ₃₀	D ₆₀	C _u	C _c	Passing No. 200 (%)	U.S.C.S
●	B-2	3.5-4.8	-	-	-	-	-	-	-	-	24	SM

PERFORMED IN GENERAL ACCORDANCE WITH ASTM D 422-63

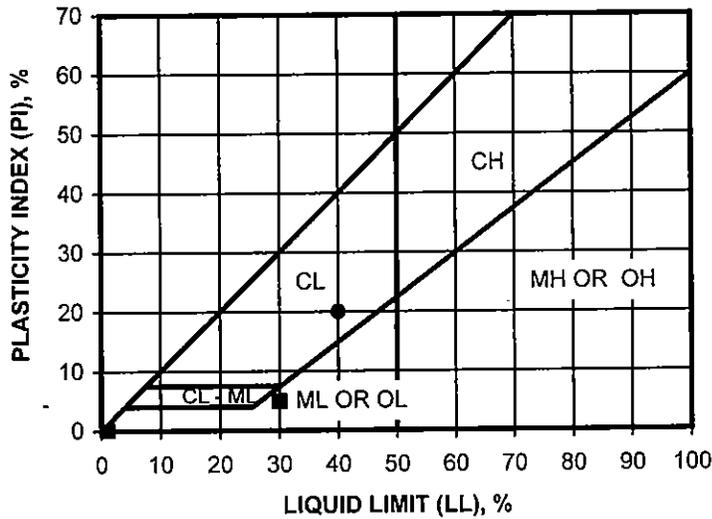
FIGURE
 B-3

SYMBOL	LOCATION	DEPTH (FT)	LL (%)	PL (%)	PI (%)	U.S.C.S. CLASSIFICATION (Minus No. 40 Sieve Fraction)	U.S.C.S. (Entire Sample)
●	B-1	1.0-2.5	40	20	20	CL	SC
■	B-2	3.5-4.8	30	25	5	ML	SM

PERFORMED IN GENERAL ACCORDANCE WITH ASTM D 4318-00

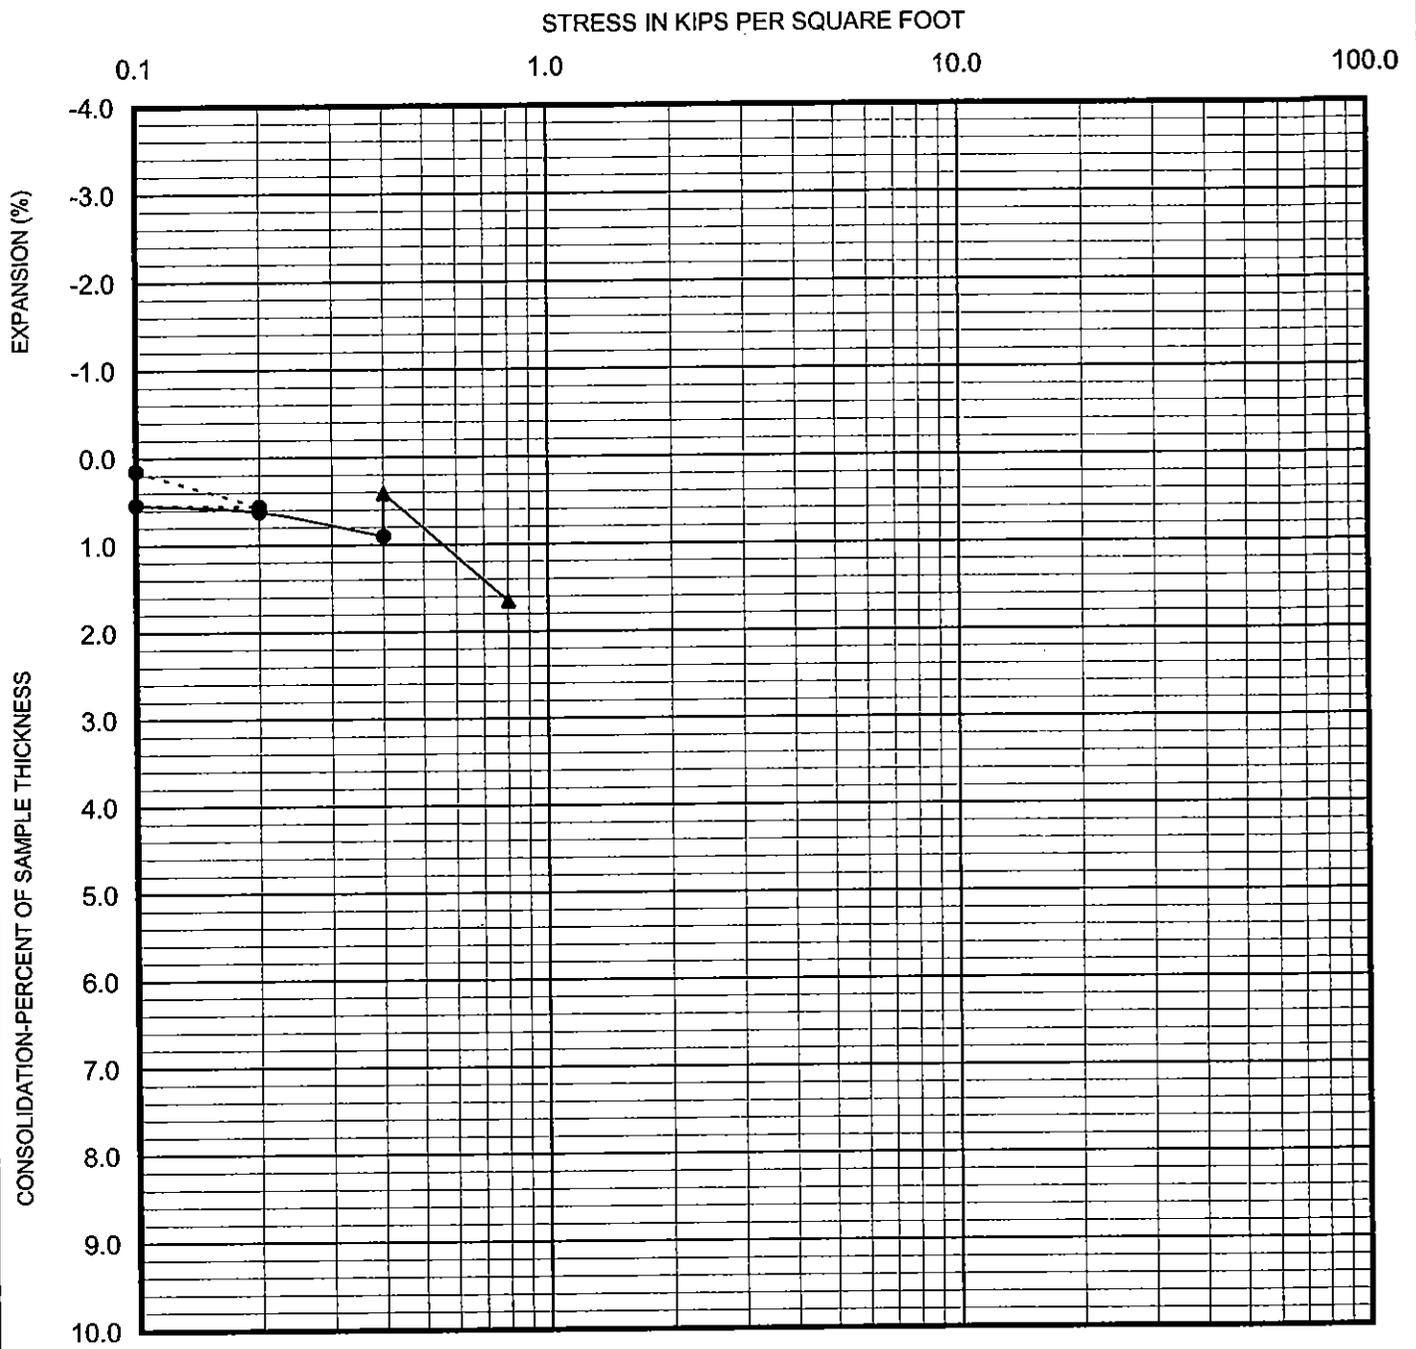
B-4

- Seating Cycle
- Loading Prior to Inundation
- ▲— Loading After Inundation
- ▲--- Rebound Cycle

Boring No. B-1
 Depth (ft.) 1.0-2.5
 Soil Type SC

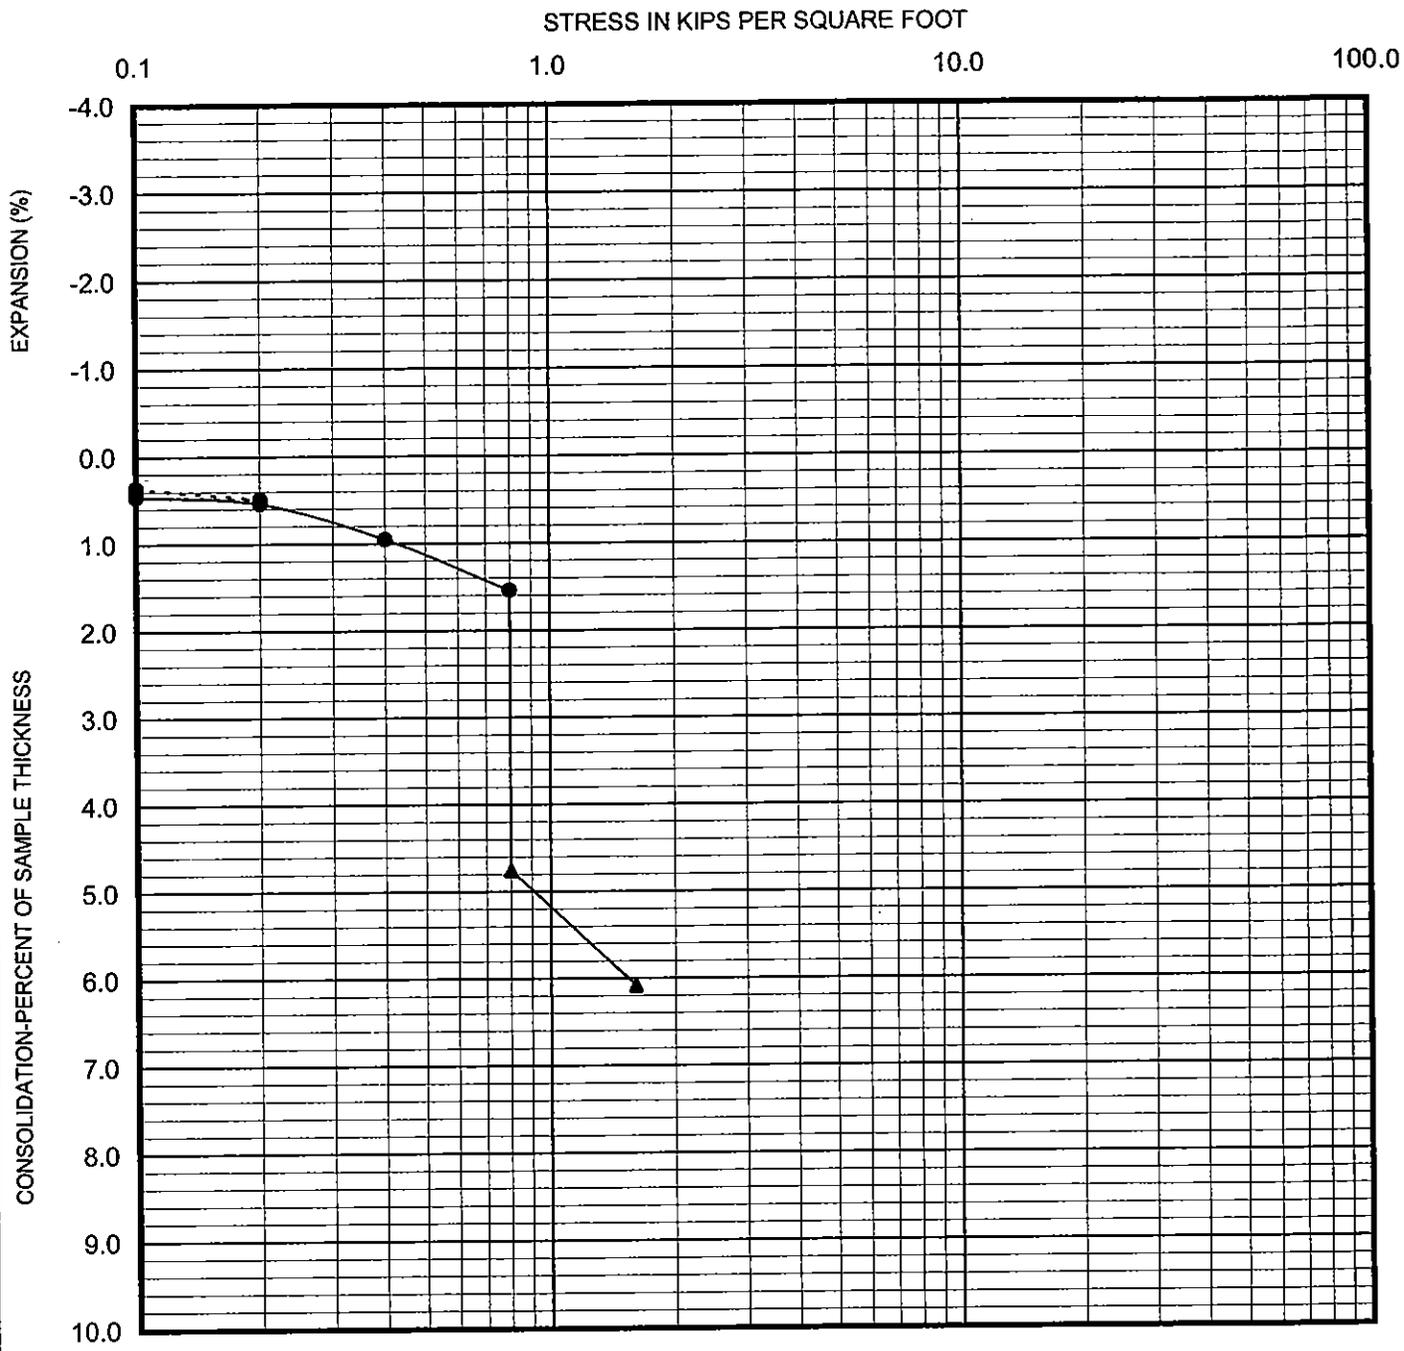
FIGURE
 B-5

- Seating Cycle
- Loading Prior to Inundation
- ▲— Loading After Inundation
- ▲--- Rebound Cycle

Boring No. B-1
 Depth (ft.) 6.0-7.4
 Soil Type SC

PERFORMED IN GENERAL ACCORDANCE WITH ASTM D 2435-96

CONSOLIDATION TEST RESULTS
 SUPERIOR FIRE STATION
 GOLF COURSE ROAD & MARY DRIVE
 SUPERIOR, ARIZONA

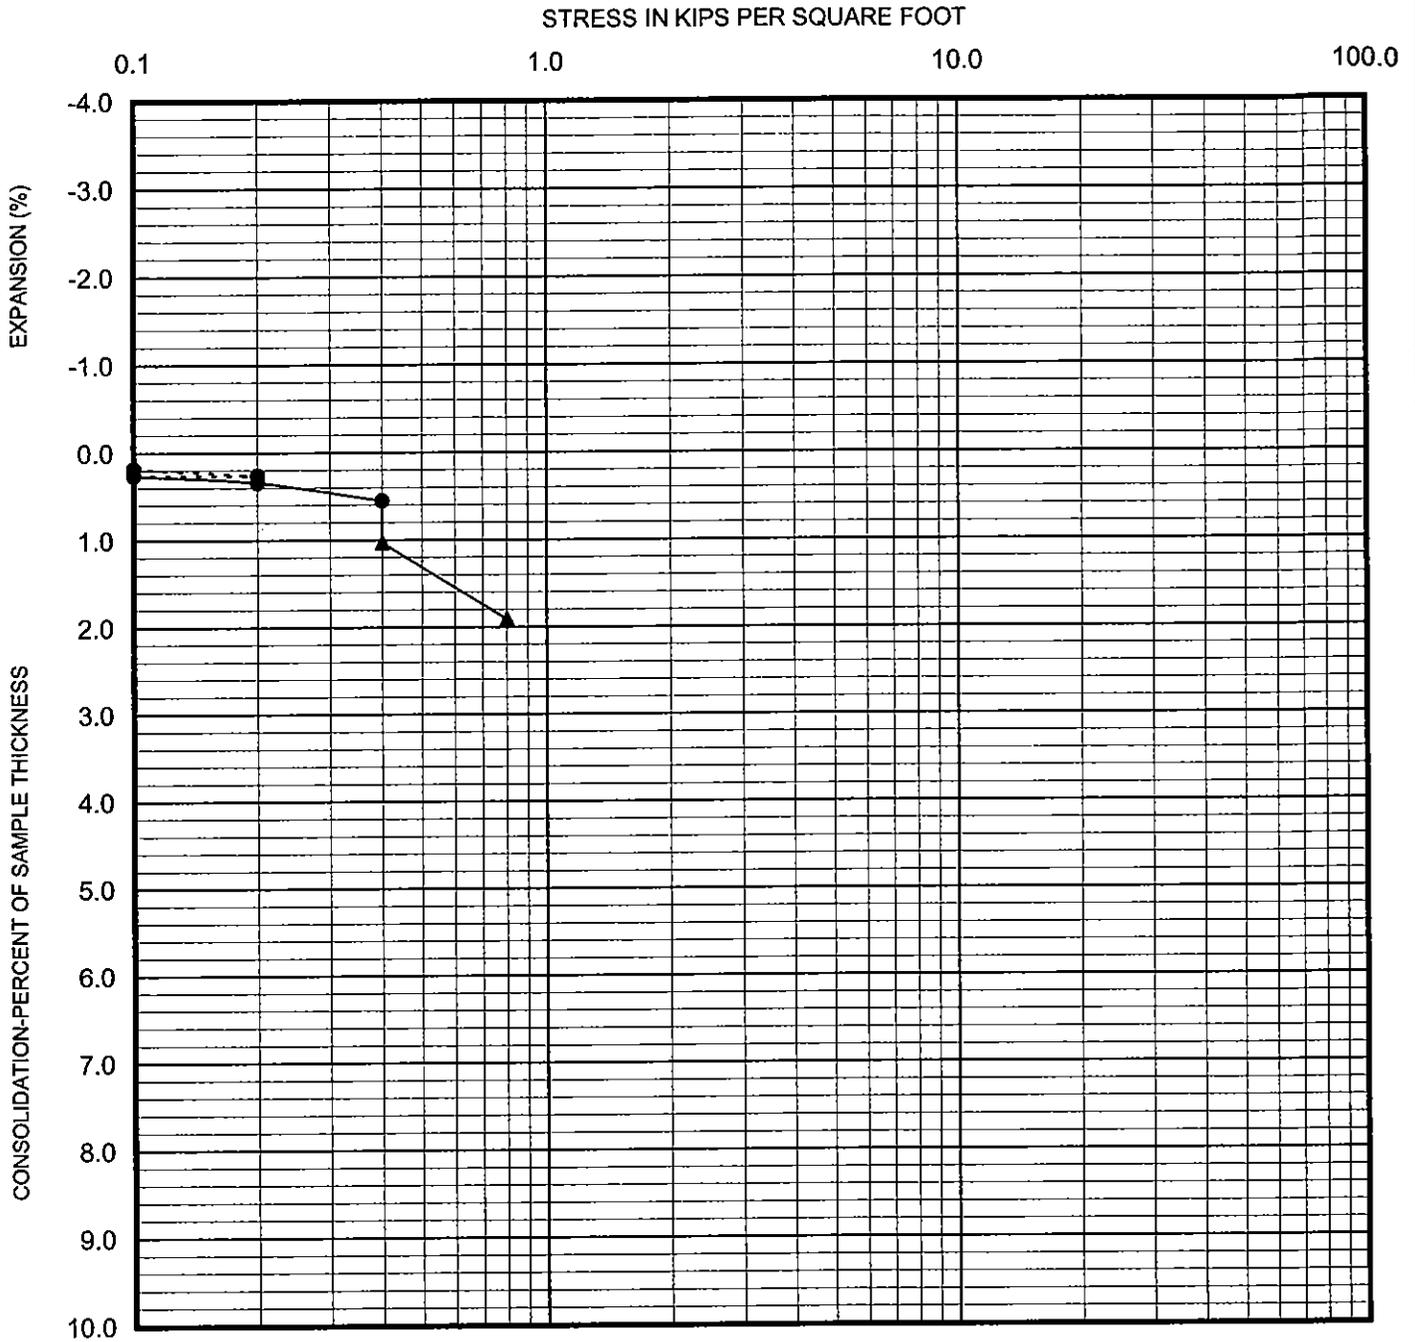
- Seating Cycle
- Loading Prior to Inundation
- ▲— Loading After Inundation
- ▲--- Rebound Cycle

Boring No. B-2
 Depth (ft.) 3.5-4.8
 Soil Type SC
